Manhole Inspection Summary

Manhole # S41CC_016MH

Insp Date: **12/12/07 10:01 AM**

Location Address: **eden and eager park**

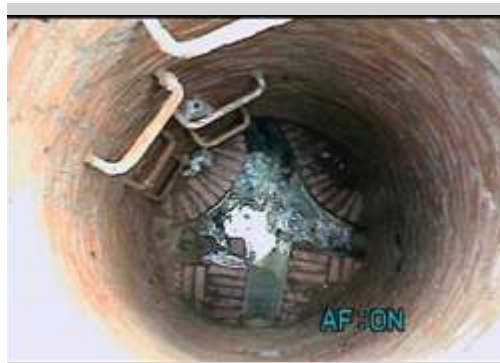
Top View

connection @ 9 Oclock abandoned

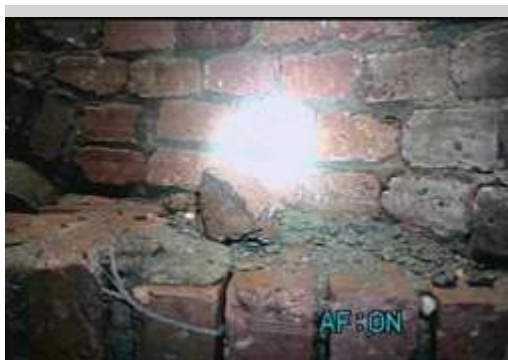
misc

Condition: ☒ Sound ☐ Cracked ☐ Root Intrusion ☐ Deteriorated ☐ Leaks ☐ Debris

bench debris

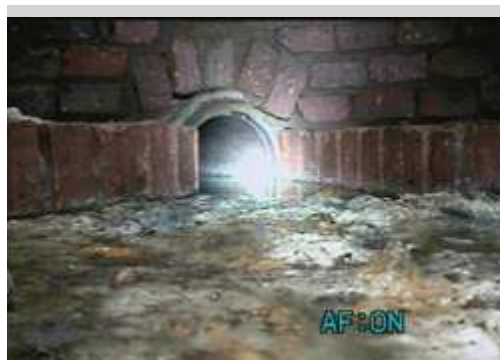
Defect 4

Condition: ☐ Sound ☐ Cracked ☐ Root Intrusion ☐ Deteriorated ☐ Leaks ☒ **Debris**

channel debris

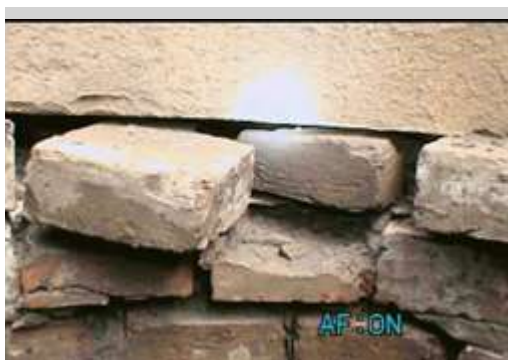
Defect 2

Condition: ☐ Sound ☐ Cracked ☐ Root Intrusion ☒ **Loose Brick** ☒ **Deteriorated**

corbel is deteriorated & has loose bricks

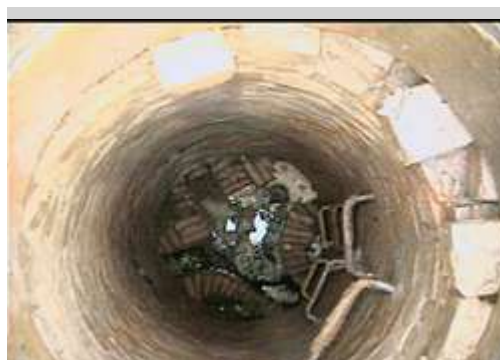
Defect 3

Offset: **3** (in.)

Count: **6** Missing: **0** ☒ **Corroded**

Frame offset, steps corroded

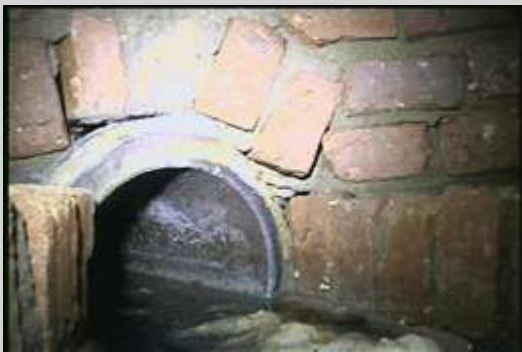
12 O'Clock Outflow

Deposits: ☐ None ☐ Mud ☐ Sludge ☒ Debris ☐ Grease

Silt Depth: 1 (in.) Deposits Extent: Light

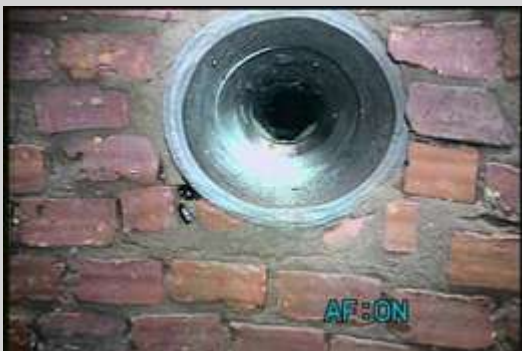
3 O'Clock Inflow

Deposits: ☐ None ☒ Mud ☐ Sludge ☐ Debris ☐ Grease

Silt Depth: 2 (in.) Deposits Extent: Medium
